U.S. DEPARTMENT OF THE INTERIOR U.S. GEOLOGICAL SURVEY

GEOLOGIC HAZARDS IN THE SUMMIT RIDGE AREA OF THE SANTA CRUZ MOUNTAINS, SANTA CRUZ COUNTY, CALIFORNIA, EVALUATED IN RESPONSE TO THE OCTOBER 17, 1989, LOMA PRIETA EARTHQUAKE: REPORT OF THE TECHNICAL ADVISORY GROUP

Report Prepared for the Federal Emergency Management Agency

U.S. Geological Survey Open-File Report 91-618

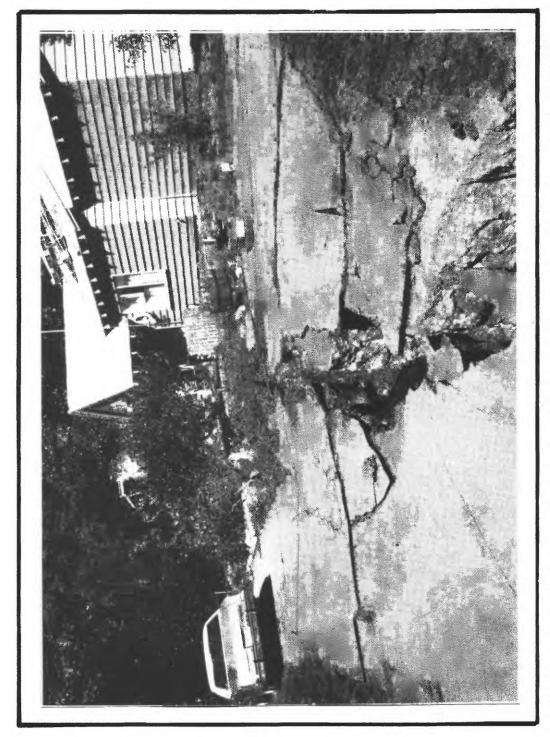
FIGURE 3.10 -Segment of scarp forming part of "Tranbarger fracture," a 4,000-foot-long zone of scarps and cracks in the Old Santa Cruz Highway area. Photograph is taken from north edge of Summit Road; view is toward the northwest.

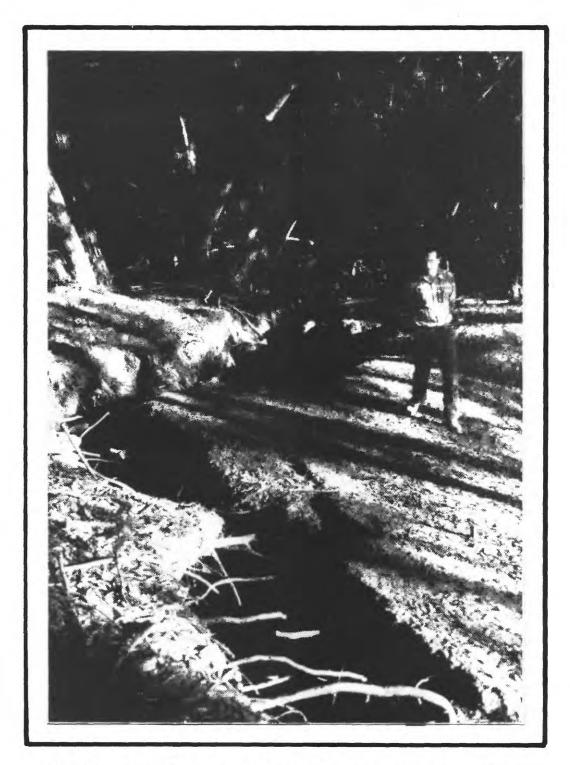
FIGURE 3.12 -Segment of arcuate, concave-downslope, ground-crack and scarp feature that forms the main scarp of the Upper Schultheis Road landslide. Photograph taken near crown of landslide; view is toward the east. Measurements near this locality showed 42 inches of extensional displacement and 18 inches of vertical displacement across this main scarp.

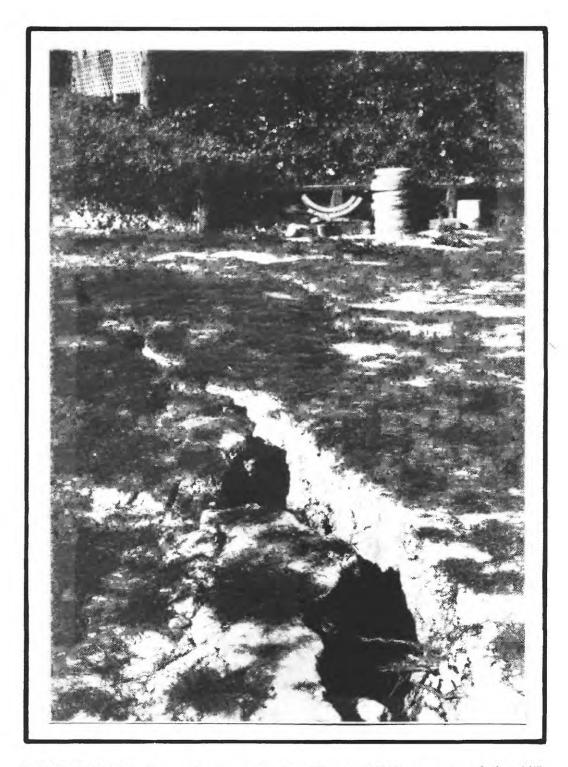
FIGURE 3.14 -Ground crack in the Sunset Drive area of the Villa Del Monte landslide complex; crack is part of 1,400-foot-long zone of cracks and scarps that delineates, in part, the head of a large landslide. (Photograph by Kevin M. Schmidt, U.S. Geological Survey).

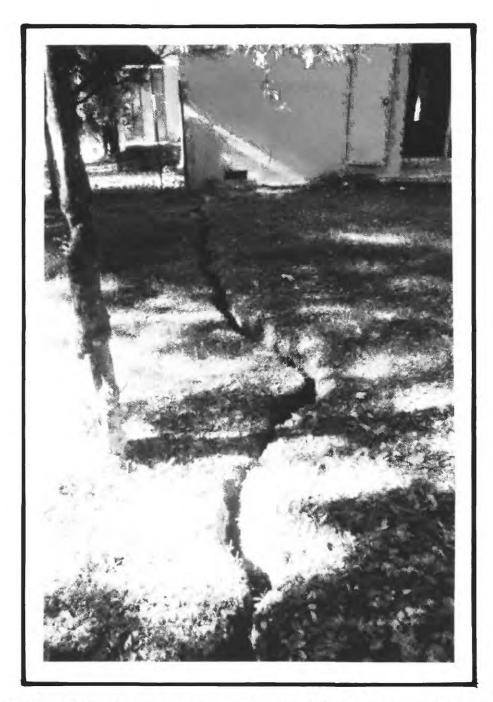
FIGURE 3.15 -Ground crack within landslide in Upper Skyview Terrace-Bel Air Court area that is part of the Villa Del Monte landslide complex. Ground crack, which passes beneath corner of house, showed 2 to 6 inches of extensional displacement and 2 inches of vertical displacement. Photograph taken near quadrilateral array #23; see figure 3.13 for location. (Photograph from Griggs and others, 1990).

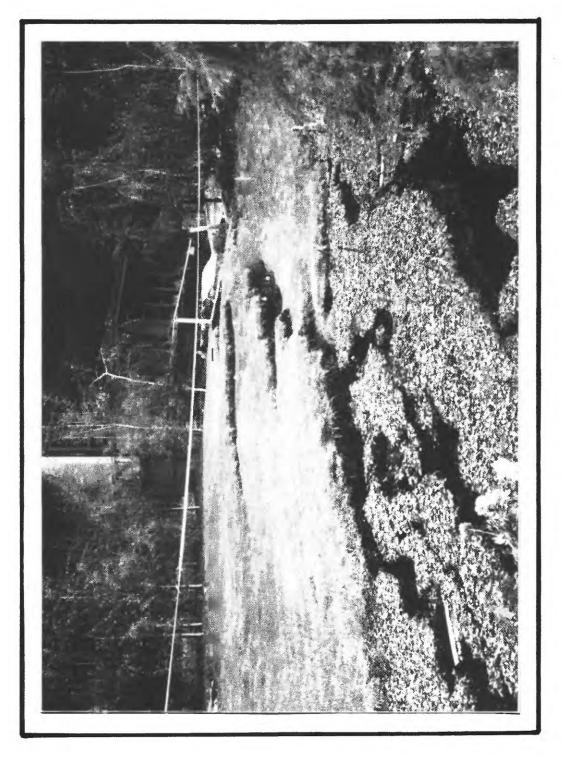
and ground cracks strike northeast and typically show displacements to the southeast. Photograph taken from just east of Deerfield Road; view is toward the northeast. FIGURE 3.16 (a) -Landslide features in Deerfield Road area of the Villa Del Monte landslide complex. Part of complex scarp several hundred feet long. This and adjacent scarps

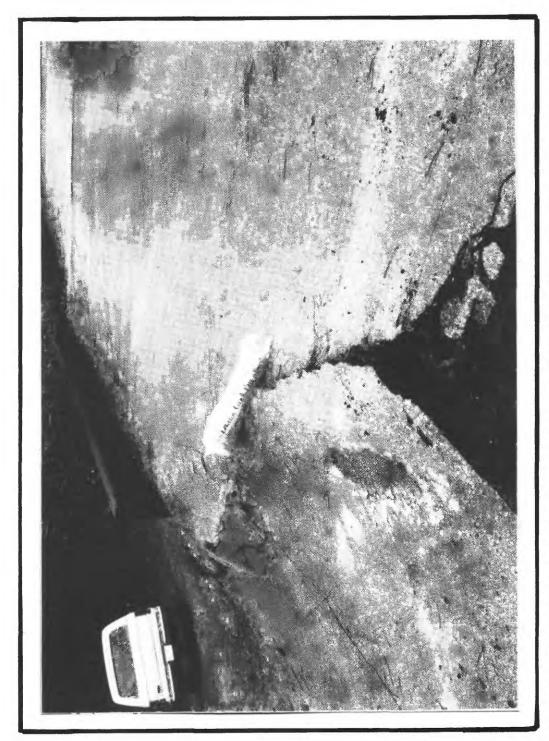
of Monte landslide complex. Compression feature, consisting of short ridge Feature inferred to be internal ridge, formed due to differential movement blocks within landslide complex. Photograph taken near Deerfield Roadcompressed ground, marked by broken and buckled driveway pavement. FIGURE 3.16 (b) -Landslide features in Deerfield Road area of the Villa Del Evergreen Lane intersection; view is toward the northwest.

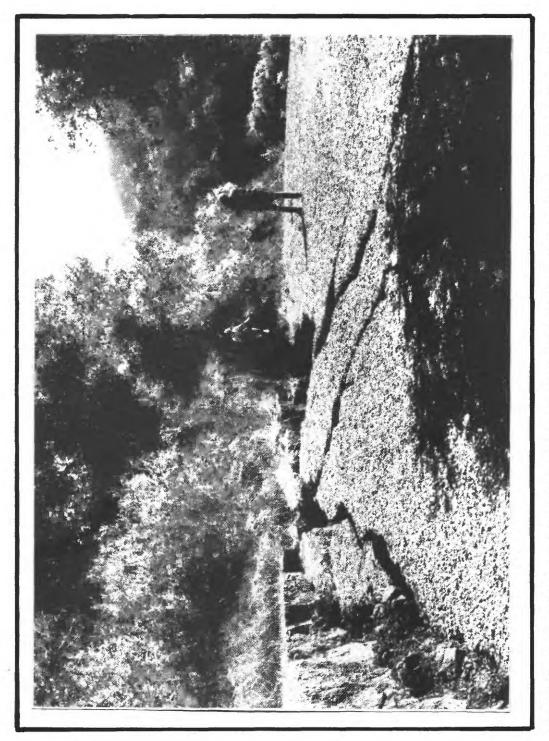
road. Total width of zone is approximately 12 feet; individual cracks are as wide as approximately 80 inches and show as much as 12 inches of vertical displacement. scarp of the Upper Morrell Road landslide. Zone shown where it crosses gravel FIGURE 3.18 -Part of complex zone of ground cracks and scarps forming the main View is toward the northeast.

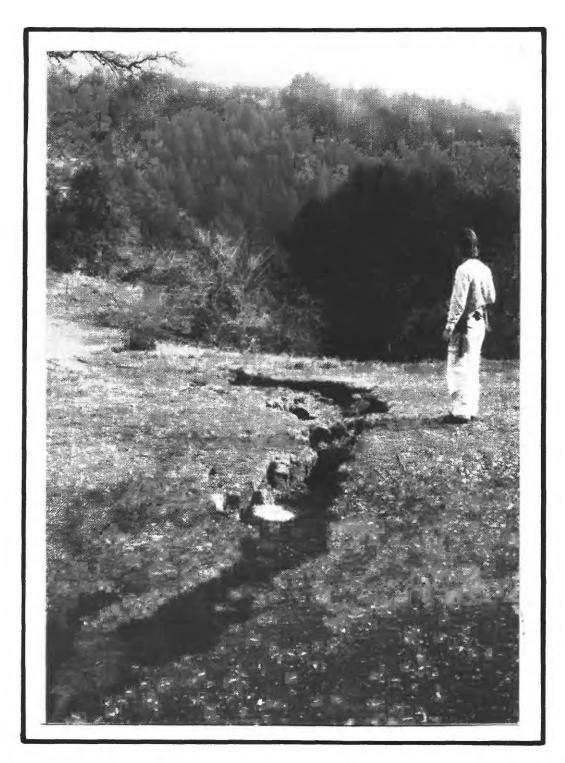
FIGURE 3.26 - Part of ground-crack and graben feature that delineates the main scarp of the Lower Schultheis Road West landslide. Stretch of scarp in photograph shows approximately 12 to 18 inches of primarily extensional movement, with a smaller vertical (down to north) component. View is toward the east. Ridge crest at this locality is to the left (north) of the photograph and thus is involved in the landslide.
